Docket No. 217 – Development and Management Plan Inspection

Northeast Utilities Service Company Certificate of Environmental Compatibility and Public Need for the construction of a 345-kV electric transmission line and reconstruction of an existing 115-kV electric transmission line between Connecticut Light and Power Company's Plumtree Substation in Bethel, through the towns of Redding, Weston, and Wilton, and to the Norwalk Substation in Norwalk, Connecticut.

Date: October 18, 2006

Location: Overhead Line (Composite 345kV and 115kV Gallows Hill to Archers Lane,
345kV H-Frame Hoyts Hill to Gallows Hill, and Norwalk Section)

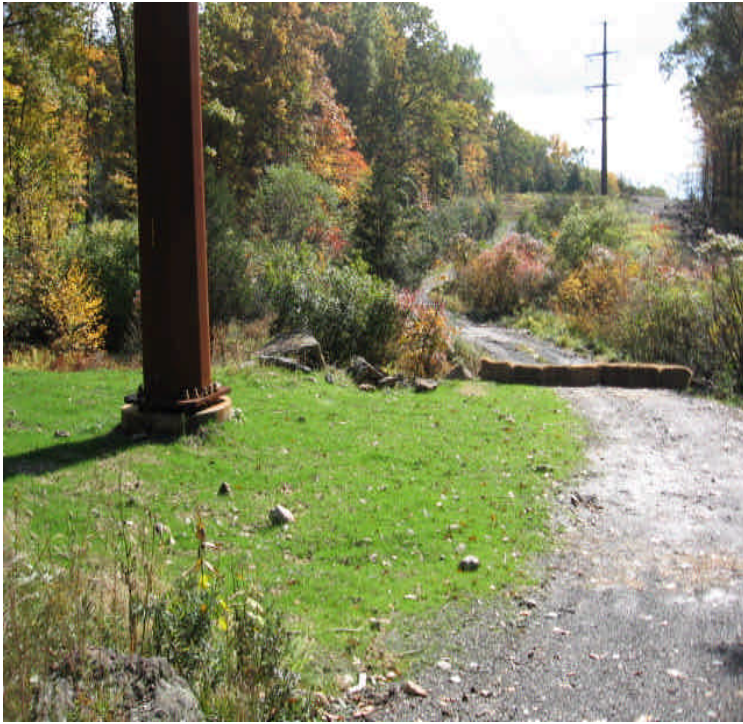
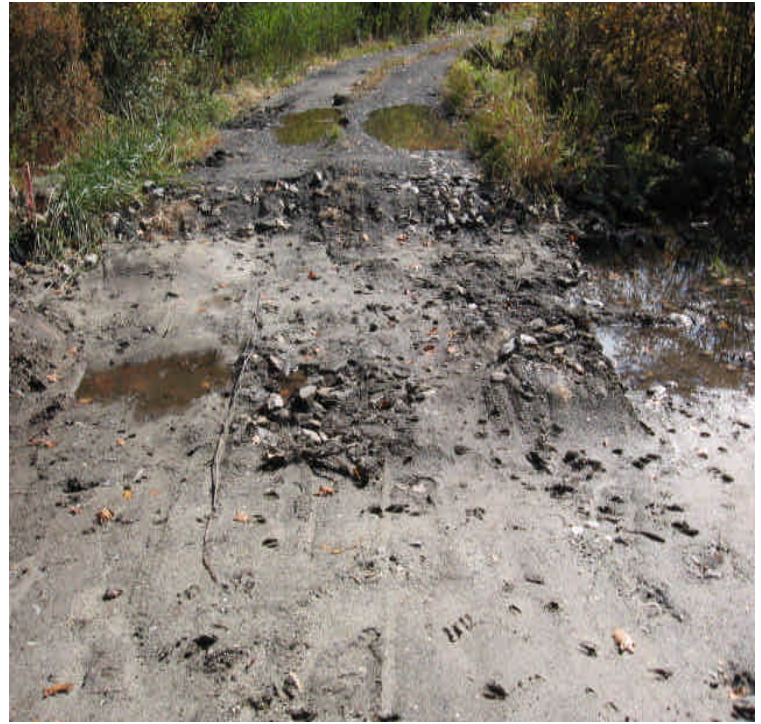
(Composite Section): Photo on the left shows disturbed areas are now stabilized with vegetation at Gallows Hill. Photo on the right shows a view of the restored crossing. Continue to monitor this area to be sure that original hydrology was established. 10/18/06.

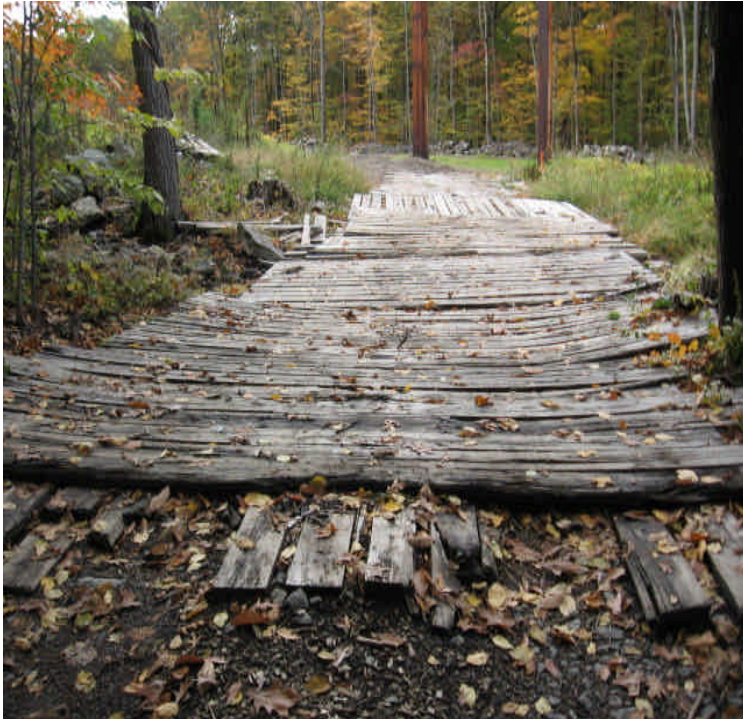
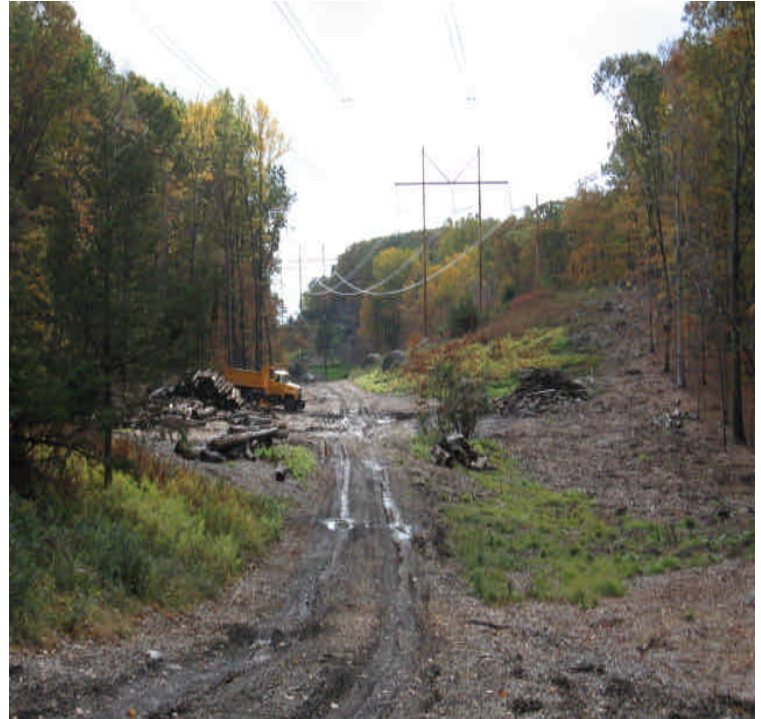
(345kV H-Frame): Both photos show views within the ROW in the Bethel Reservoir section. Photo on the left shows mats remaining at the stream crossing. Photo on the right shows equipment and lumber remain within the ROW in this section. 10/18/06.

345kV H-Frame	- Work areas are accessed from various roadways. Restoration is	-Continue restoration and replace silt fence with hay bales in appropriate locations. Remove mats	-Most mats were removed.

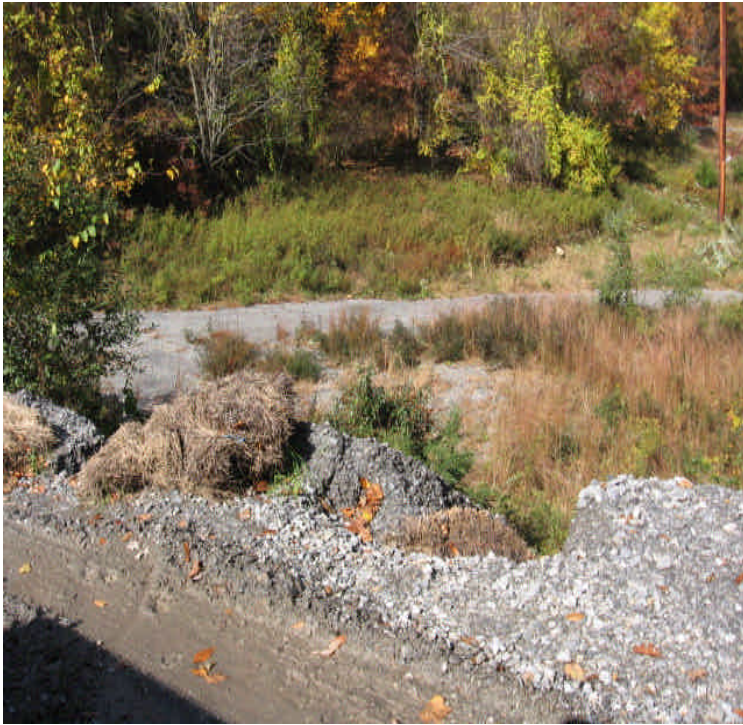
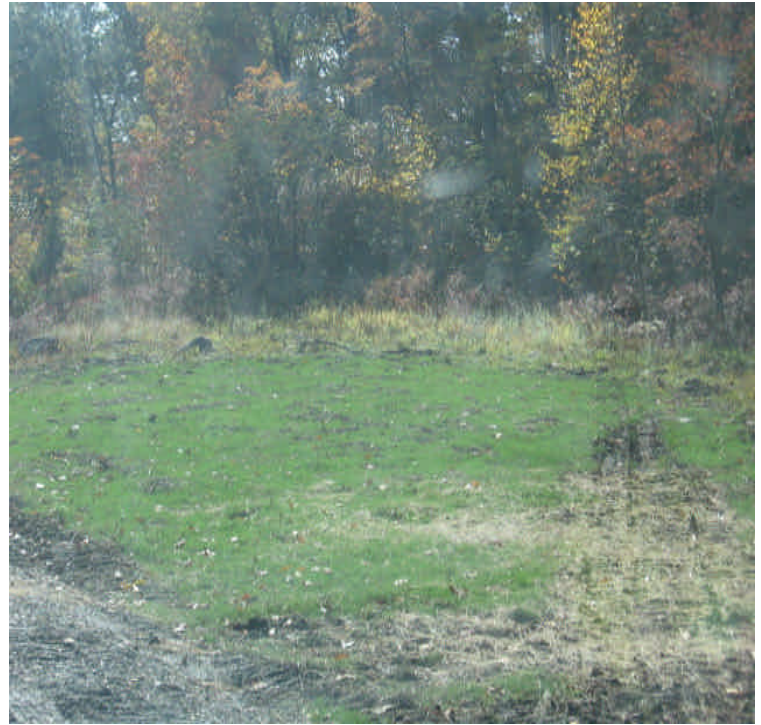
Photo on the left shows a view of the erosion continuing in the access road near structure #31 off Costa Lane. Photo on the right shows significant grass growth in the restored areas. 10/18/06.

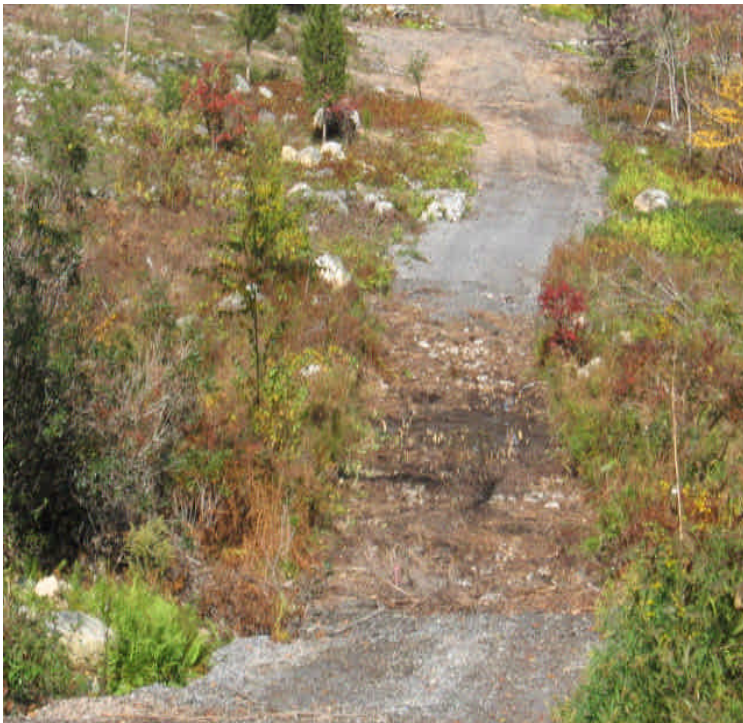
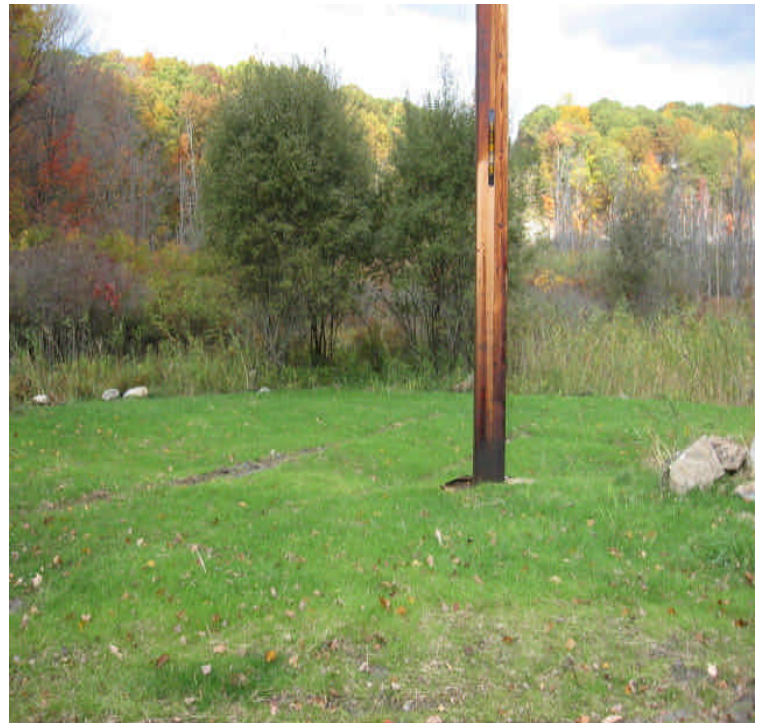
Photo on the left shows mats were removed from the wetland crossing within the ROW off Costa Lane. Photo on the right shows the area at pole #25 is stabilized with vegetation. Silt fence should be removed here. 10/18/06.

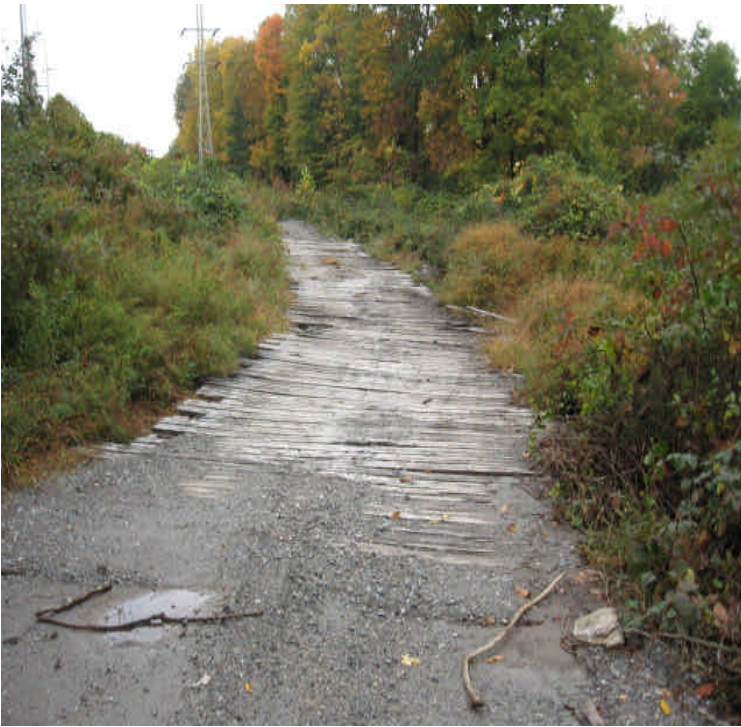
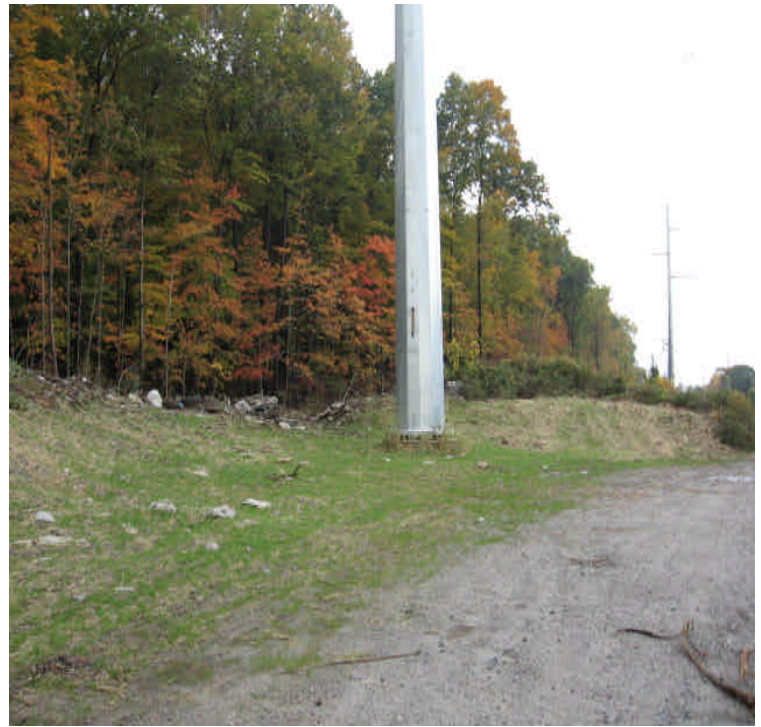
(Norwalk Section): Both photos show views of the ROW off Kent Road south. Photo on the left shows mats remaining at the wetland crossings. Photo on the right shows disturbed areas are stabilizing with vegetation. 10/18/06

Kent Road (south) - Wetland crossings remain matted in the Kent Rd south section. Haybales and silt fence at the wash out areas are deteriorating. 9/20-10/18/06.	- Maintain hay bales at wash out areas until this area is stabilized. Remove mats from wetland areas when restoration activities are nearing completion. 9/20-10/18/06.	-Still needs attention.

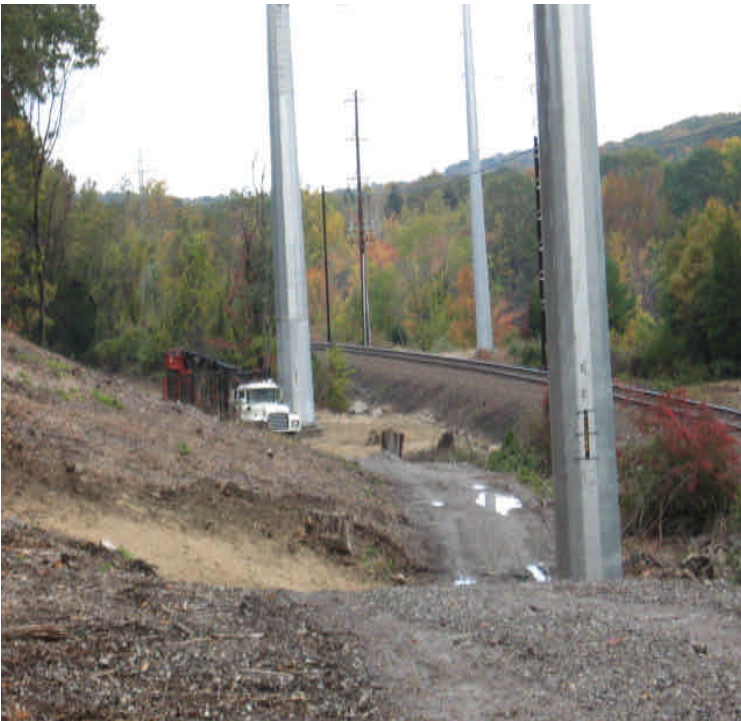
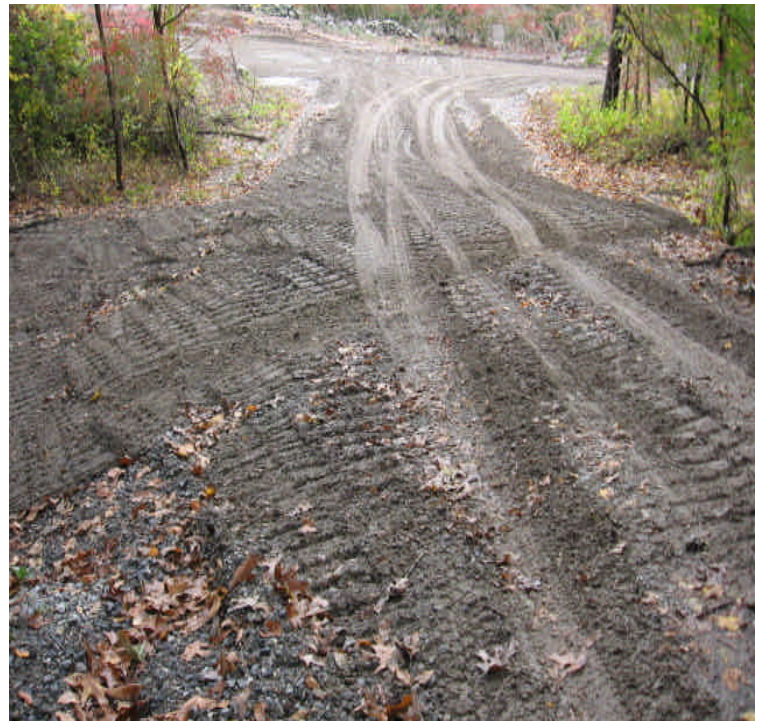
Both photos show views of the ROW off Kent Road north. Photo on the left shows disturbed areas have been re-graded to original conditions, mulched with hay, and seeded. Photo on the right shows a view of the water bar constructed within the access road to the north. 10/18/06.

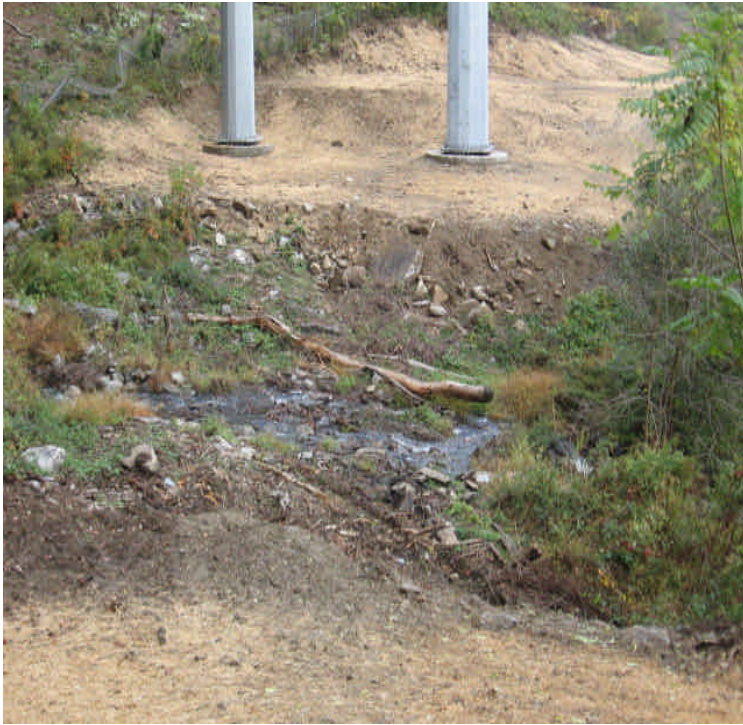
Areas of Inspection	Observation	Recommended Action	Corrective Action
Kent Rd. (North)	<p>#11064 were seeded and mulched but the stream is still not protected by erosion controls. 10/4-10/18/06.</p> <p>- Grass growth was noted at structure #11080, off Broad Street south, but washouts in the mulch continue. The silt fence here is stressed. 10/04-10/18/06</p> <p>-The Broad Street north and Rt 7 extension sections have stabilized. The Rt 7 area will no longer be inspected. 10/18/06</p> <p>- Restoration activities have begun at Kent Road north. Most of the disturbed areas within the ROW have been re-graded to original conditions. Crews were applying hay mulch and seed at the time of inspection. Mats remain at the wetland crossing. 10/18/06.</p>	<p>prevent sediment from entering the stream channel. 10/18/06.</p> <p>- Repair silt fence and monitor. Further grass cover is not expected prior to the winter. 10/4-10/18/06.</p> <p>-These areas have stabilized and remaining silt fence should be removed. 10/18/06</p> <p>-Continue restoration and clean up in previously disturbed areas. Restore as near as possible to original conditions. 10/18/06.</p>	<p>- Restoration was noted but still needs attention</p> <p>- Need to remove silt fence and Broad St north will also be removed from inspection.</p> <p>-Restoration efforts noted.</p>

Photo on the right shows a close up of the stream channel at the base of the slope near structure #11064 off North Seir Hill Road. The stream is still not protected by erosion controls. Photo on the right shows disturbed areas off Perry Ave north have been seeded and mulched. 10/18/06.

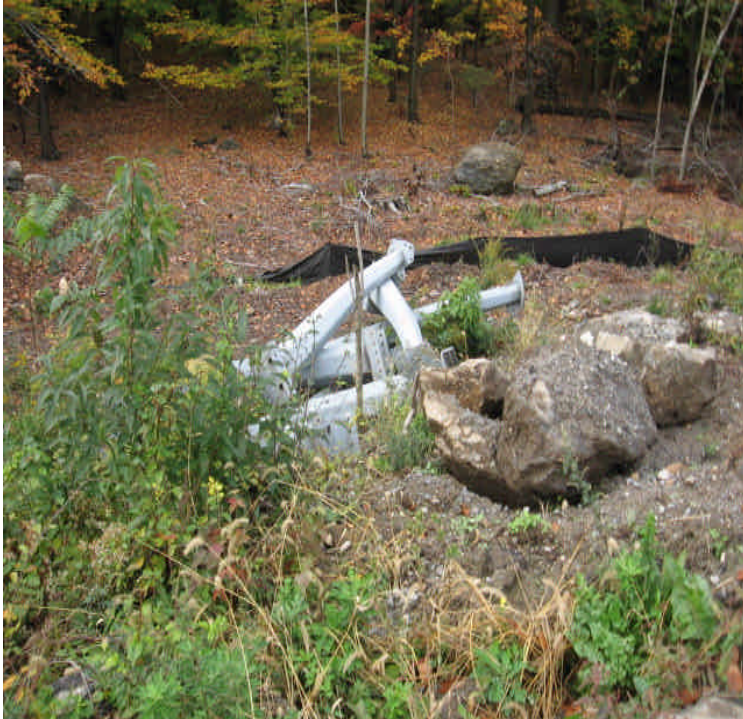
Photo on the left shows spare structure arms are still being stored in the ROW off Perry Ave north. Photo on the right shows sediment overwhelming the erosion controls at structure #1180. 10/18/06.
